PERFORMANCE TESTS OF SELECTED PLASTIC DRUMS

Prepared for
Transportation Development Centre
Transport Canada

by
Environmental Simulation Lab
Centre for Surface Transportation Technology
National Research Council Canada

FEBRUARY 2005

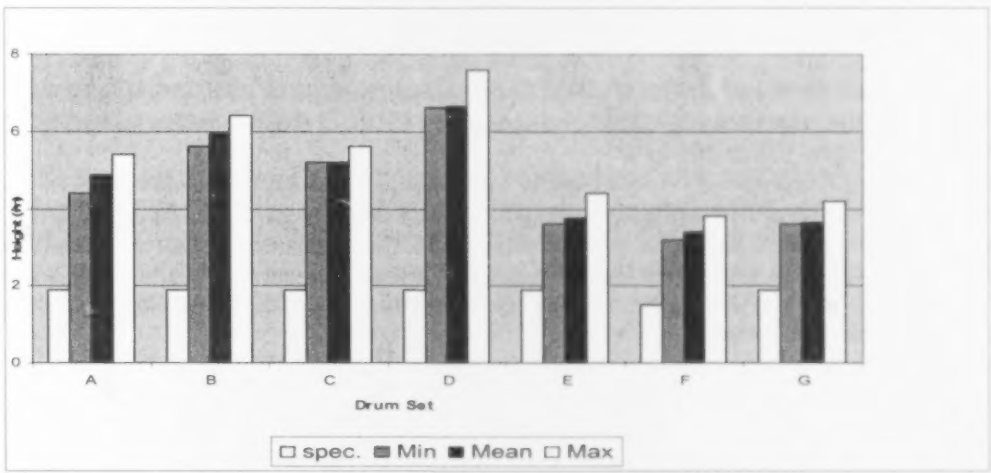
Figure 3: Summary of Drop Heights

Figure 3 shows the minimum, maximum and mean failure heights along with the certified rating. From Figure 3 it can be seen that all the drums tested demonstrated fairly consistent failure heights, within each set, and that all of them quite comfortably exceeded their required drop test heights.

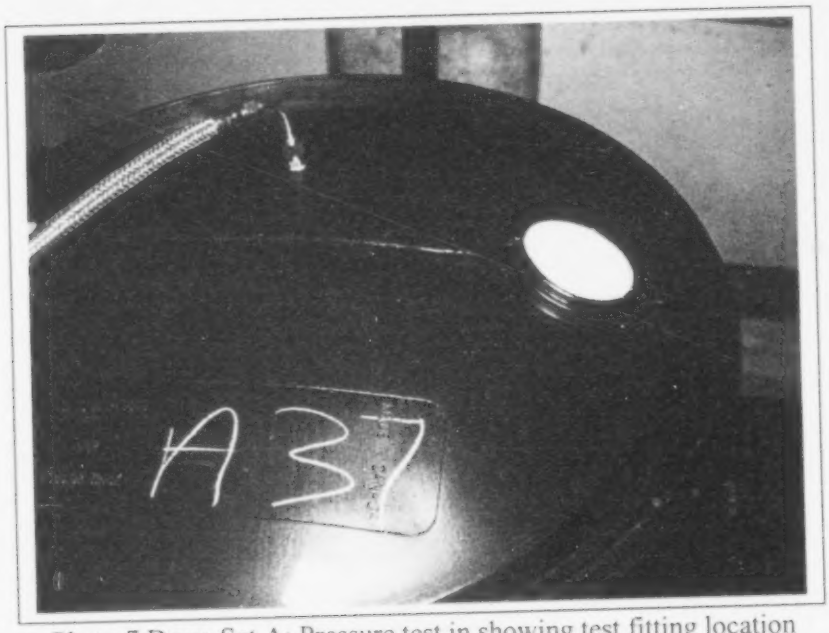
Out of all the failures, most were due to splitting of the top cover along the mold part line. A few drums split where the cover joined the body. There were no failures of either closure observed during the official series but one NPS closure leaked and another popped off during the preliminary tests.

Photo 5 Drum Set A: Typical failure mode - Fracture at cover mold line

Photo 6 Drum Set A: Typical failure mode - Fracture at cover/body seam

Photo 7 Drum Set A: Pressure test in showing test fitting location

Photo 8 Drum Set A: Typical pressure test failure mode - Drip from NPS closure

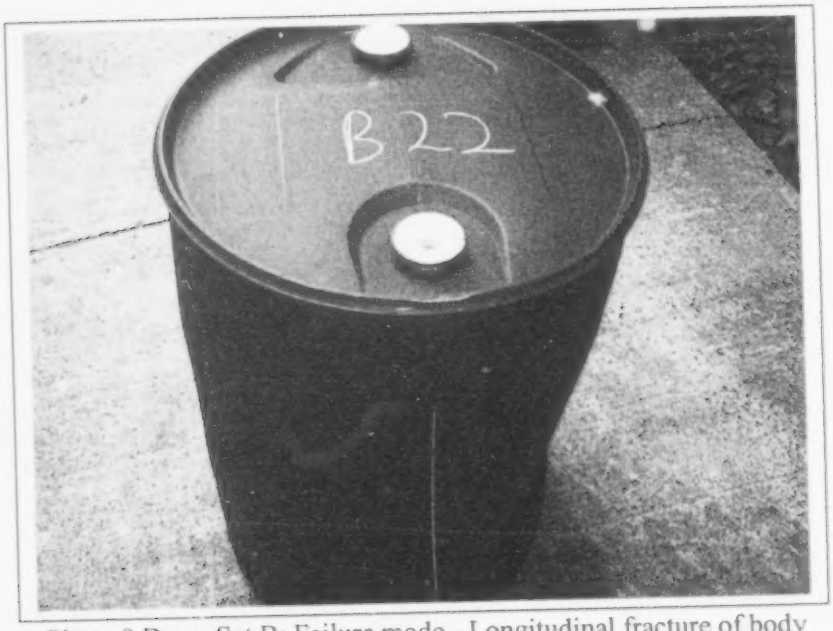
Photo 9 Drum Set B: Failure mode - Longitudinal fracture of body

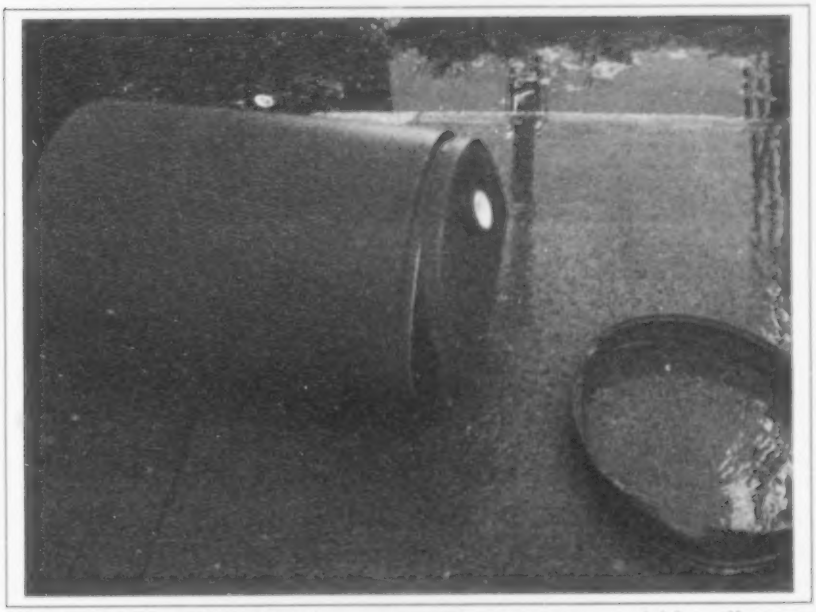
Set C was one of two that used a separate, pressed on ring to form the spill containment reservoir around the top. These sometimes came off when the drum was dropped, and the failure sometimes occurred around the recess into which this ring was pressed.

Photo 11 Drum Set C: Failure mode - Fracture at cover/sidewall seam
(note top ring separated)

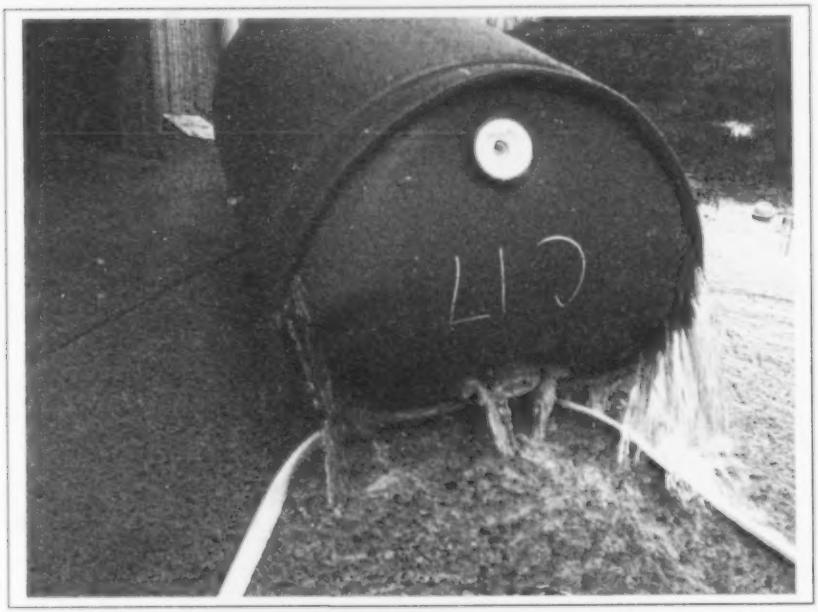
Photo 12 Drum Set C: Failure mode - Fracture at cover/sidewall seam, under the recess
where top ring locates

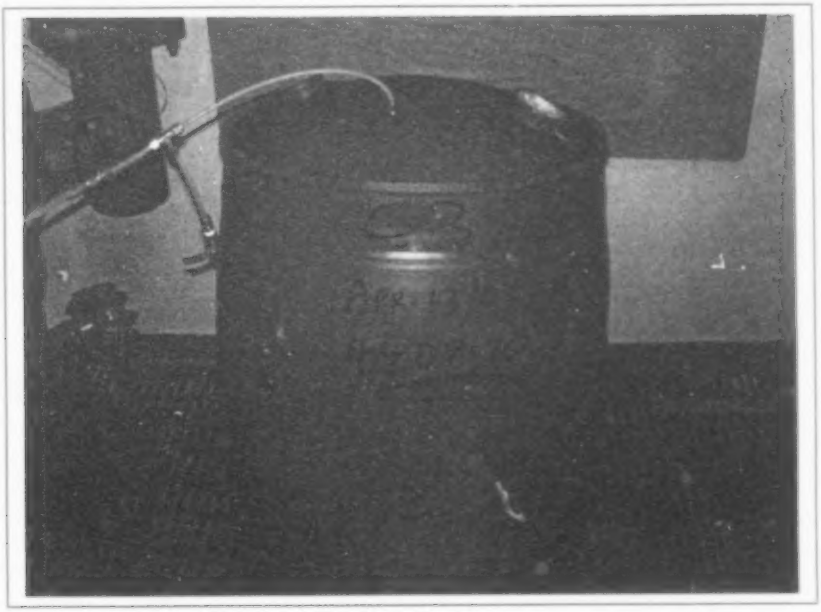
Photo 13 Drum Set C: Pressure test underway

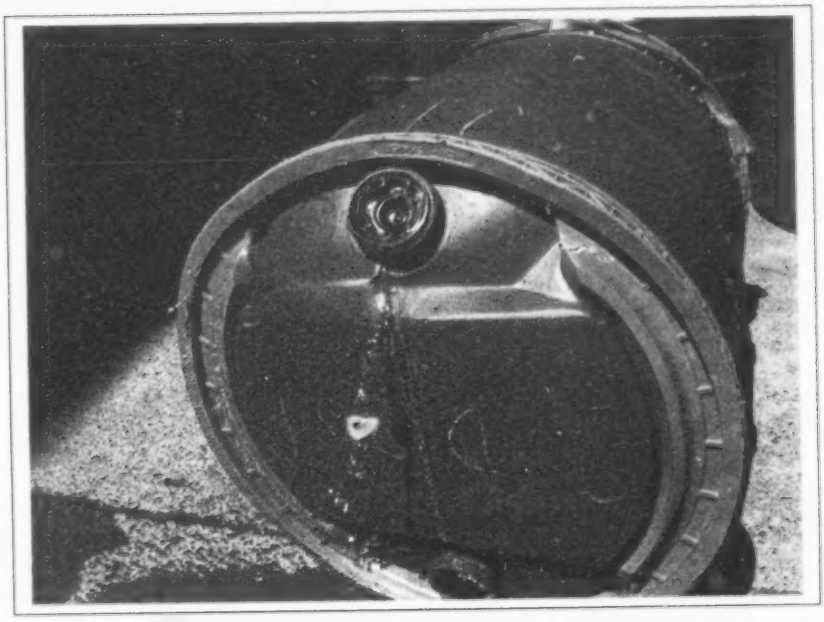
Photo 17 Drum Set D: Example of severely distorted closure neck – Still no leaks

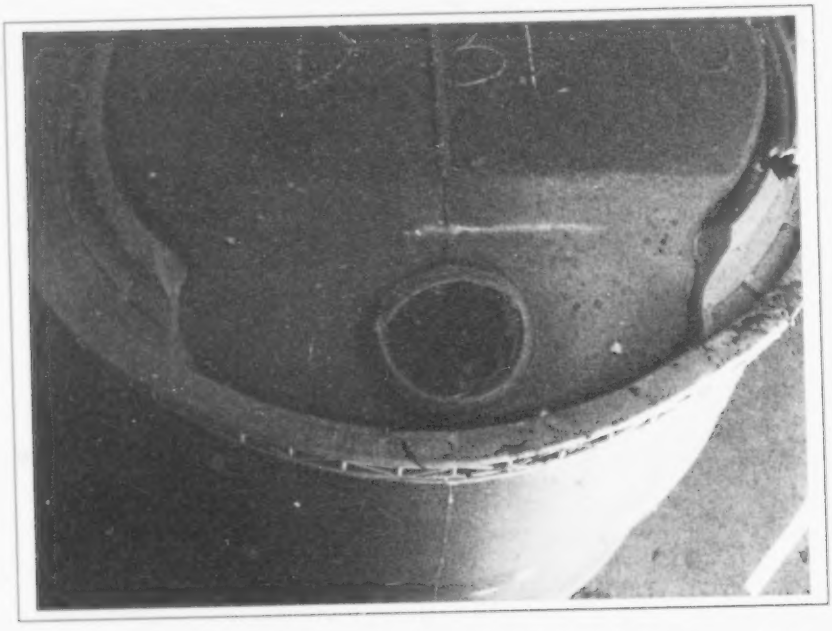
Photo 18 Drum Set D: Failure mode - Small split on edge of top/sidewall seam

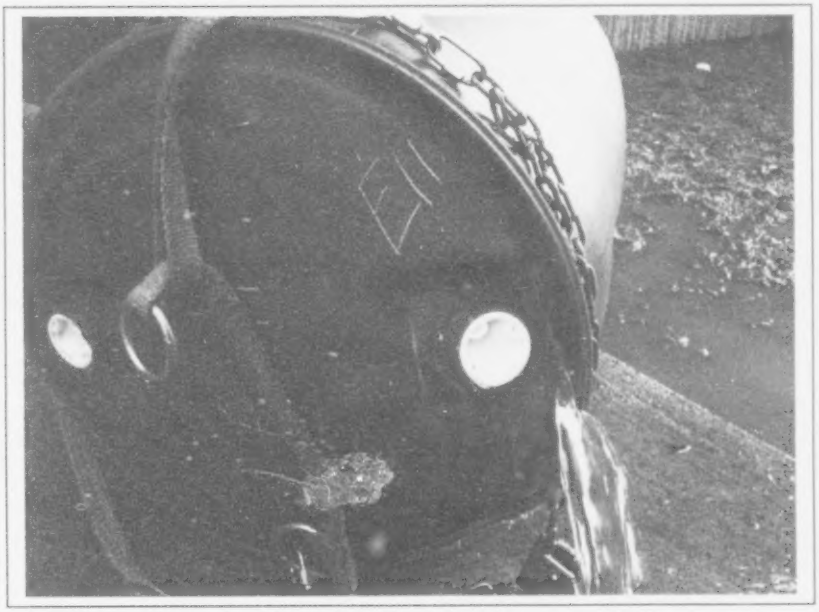
Photo 21 Drum Set E: Failure mode - Small hole near closure neck

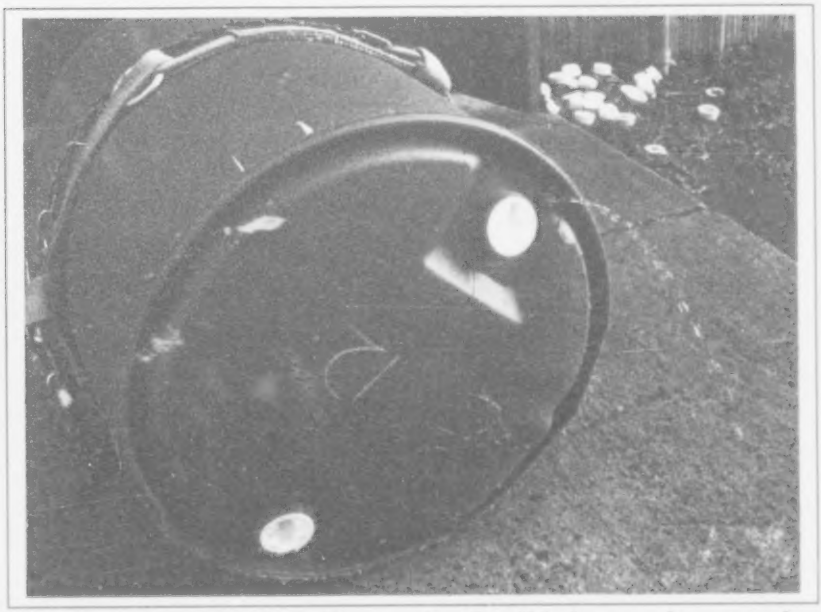
Photo 22 Drum Set E: Failure mode - Separation at edge of closure well

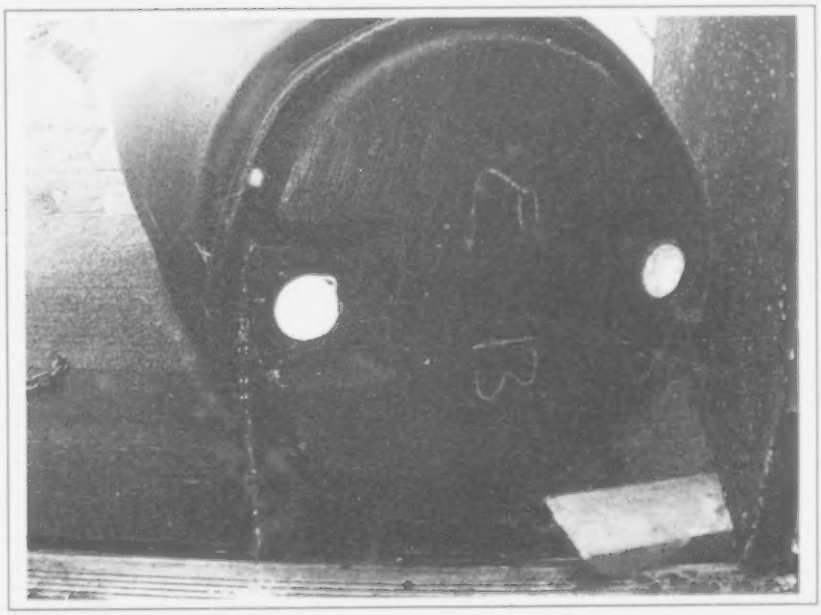
Photo 23 Drum Set F: Failure mode - Longitudinal split along sidewall

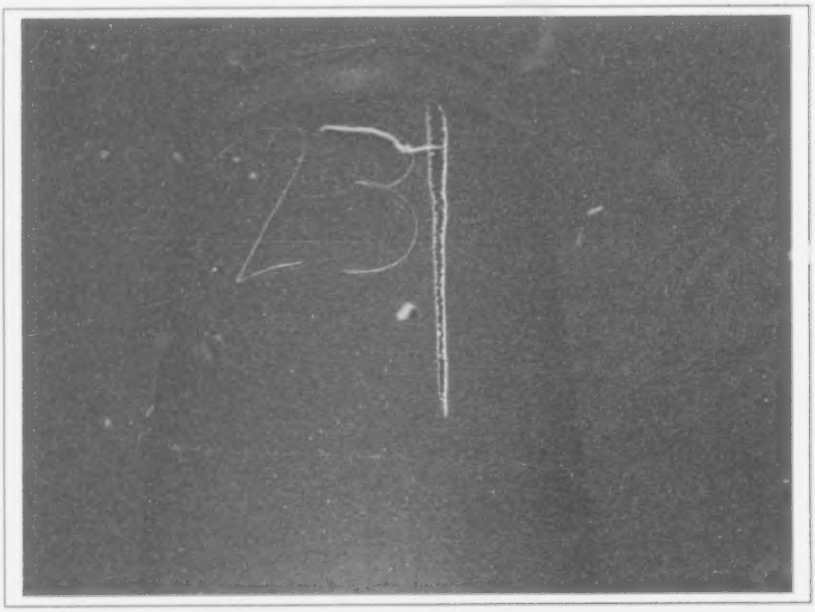
Photo 24 Drum Set F: Second failure mode - Rupture around closure

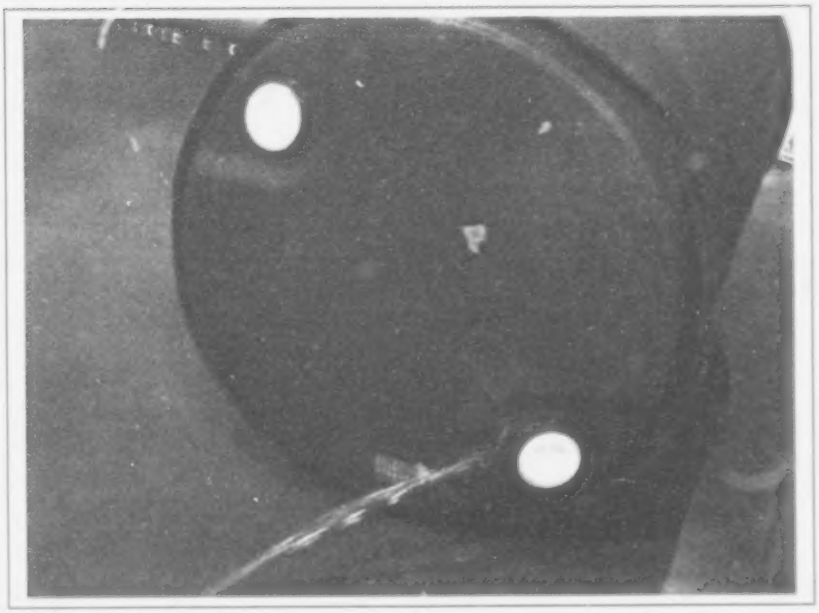
Photo 25 Drum Set F: Close-up of drum top showing delamination of material

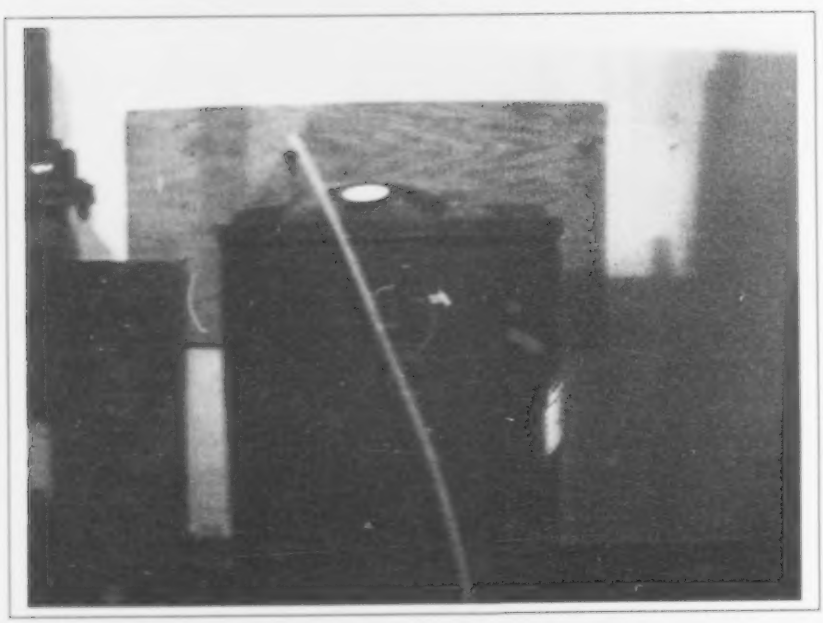
The mean and standard deviation were calculated to be 3.64 m and 0.27 m, respectively, for the six o'clock drops. The failure modes were about evenly divided between closure leakage, and the top fracturing in the vicinity of the closure. A few drums also failed by longitudinal fractures along the body sidewalls.

Photo 27 Drum Set G: Failed drum showing
extent of distortion of top handle area

Photo 28 Drum Set G: Typical failure mode - Rupture at top/sidewall line

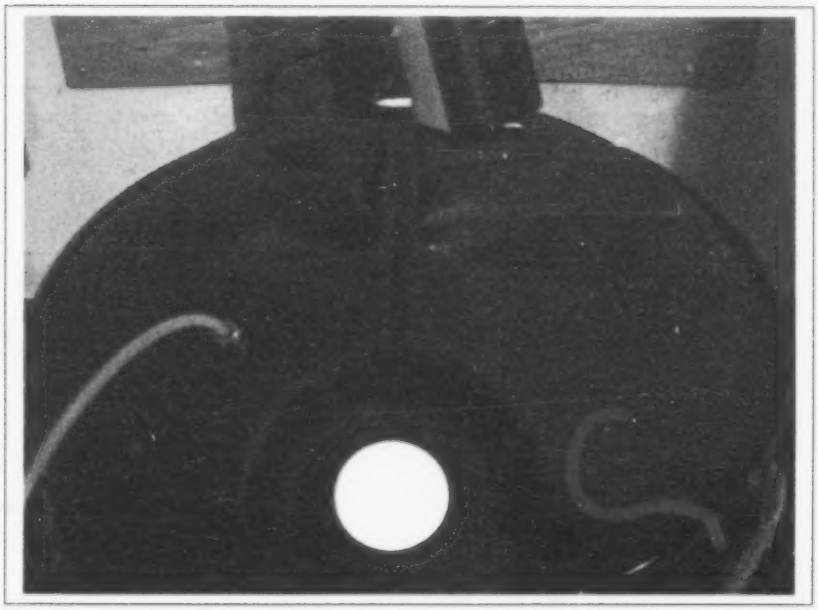
Photo 30 Drum Set G: Pressure test under way

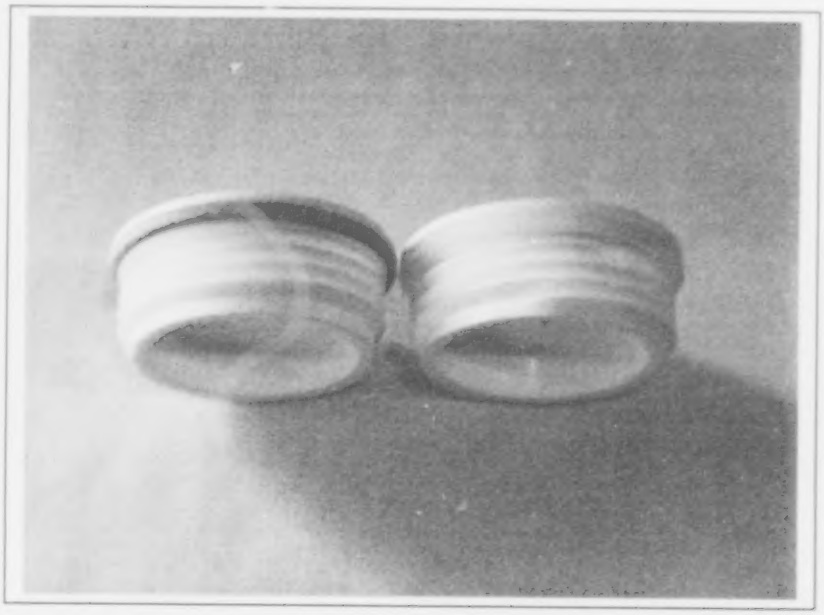
The type of gaskets used with the bungs also varied considerably, with some using a soft rubber-like rectangular section gasket, and others using a round section gasket of a harder plastic material. (Photo 31)

This was particularly difficult for closures with the hard plastic gaskets. The torque of 27.1 J (20 ft-lb) that worked for closures with soft rubber gaskets was entirely inadequate for closures with hard plastic gaskets. After several attempts to contact the manufacturers, it was decided to try increasing the torque until a value was found that appeared to work. Often a value of 40.7 to 47.5 J (30 to 34 ft-lb) would seal, but 54.2 J (40 ft-lb) would cause the threads to be stripped, while lower values would result in a leaking closure at very low pressures.

Photo 31 Comparison of two gasket types: Rectangular section, soft rubber on the left, round section, hard plastic on the right (both closures with buttress threads)

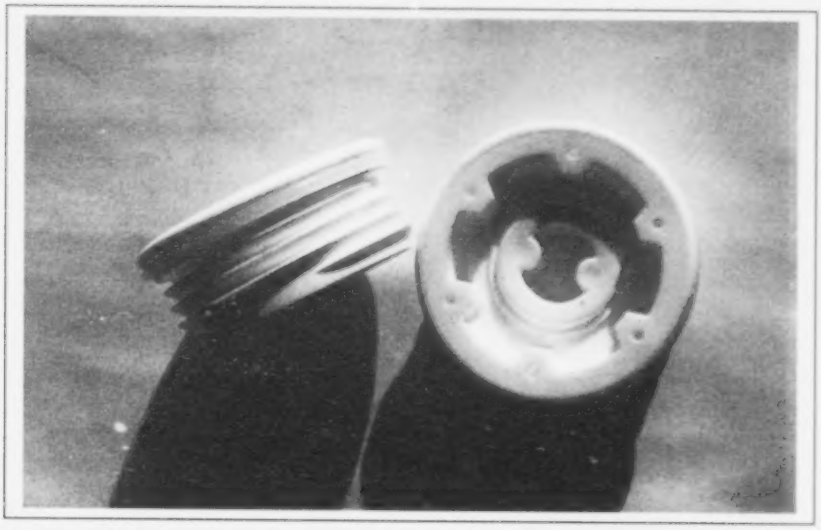
most common system on the drums bought in North America consisted of two closures: a 2 in. NPS threaded bung and a 2 in. buttress thread bung on the opposite side. Some of the drums purchased overseas came with both bungs having 2 in. buttress threads. Some of the 2 in. bungs also had a ¾ in. bung in the centre (Photo 32). Others had a ¾ in. threaded recess with a "knock-out diaphragm" but no bung. (Photo 33)

Photo 32 Detail of one closure type: Buttress thread, round, hard plastic gasket, and small secondary bung in the centre

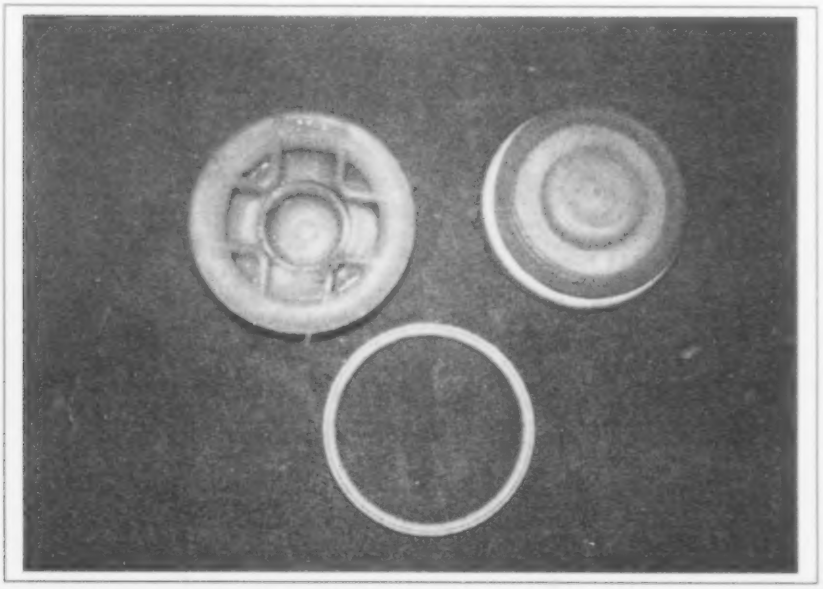
Photo 33 Example of a type c closure:
Note the small, threaded knockout bung in the centre

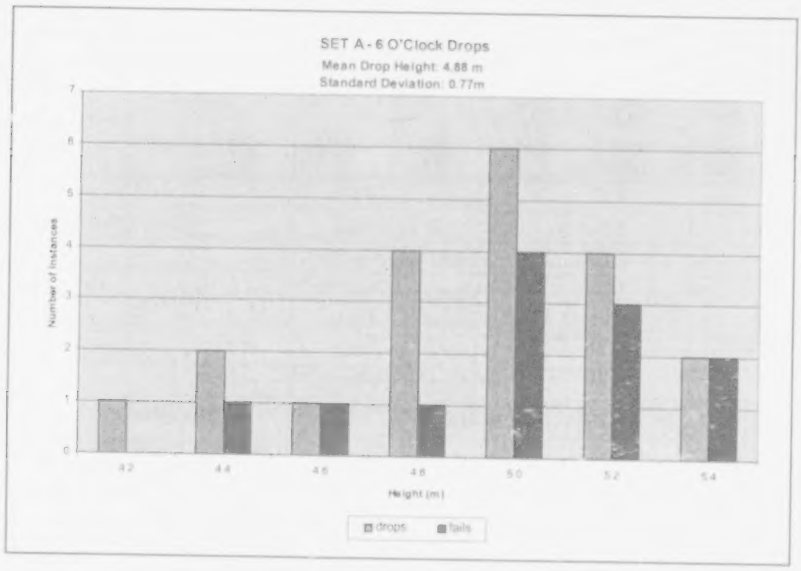
Pressure Test Results, Drum Set A

Drops in Set A reached heights of approximately 5 m before failure. During the preliminary drops, the drums appeared to be able to withstand higher drops in the 8 o'clock orientation as opposed to 6 o'clock orientation. The difference was not as pronounced as in some other sets, but in the limited number of samples available for preliminary testing there appeared to be enough of a difference to choose the 6 o'clock orientation for the official drops. The mean drop height was calculated to be 4.88 m with a standard deviation of 0.77 m.

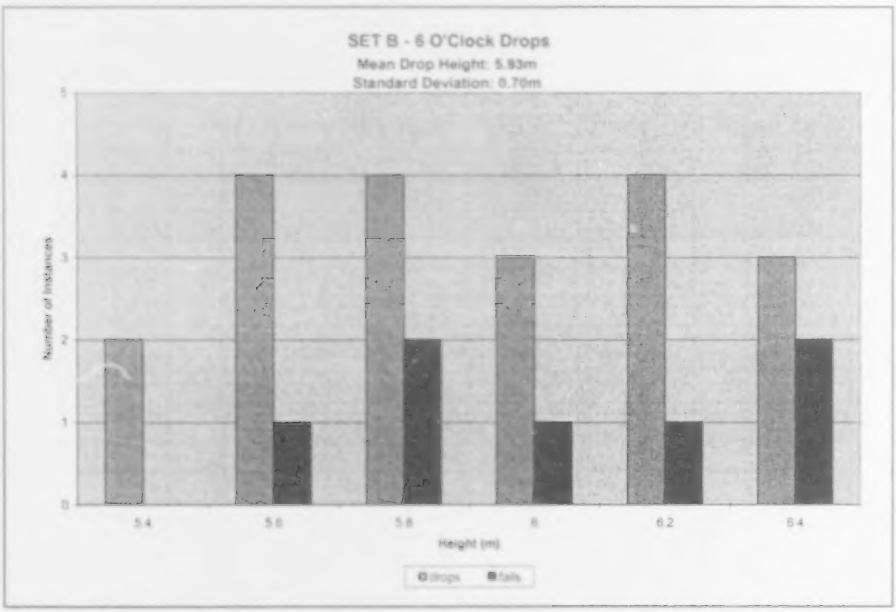
Pressure Test Results, Drum Set B

The mean failure height was 5.93 m with a standard deviation of 0.70 m. Most failures occurred at the 2 in. NPS thread closure, even though the impact was on the buttress thread closure. Usually the failure was in the form of a steady drip from the closure, and two of the closures popped off altogether.

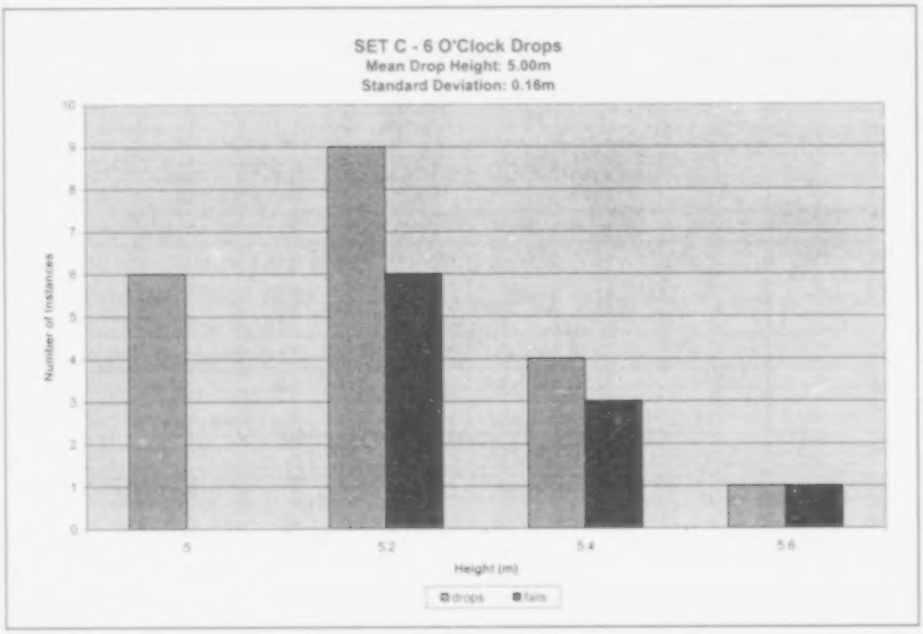
Pressure Test Results, Drum Set C

The mean was calculated to be 5.2 m with a standard deviation of 0.16 m. There were no closure leaks. Most failures were as a result of splitting at the mold line running across the top.

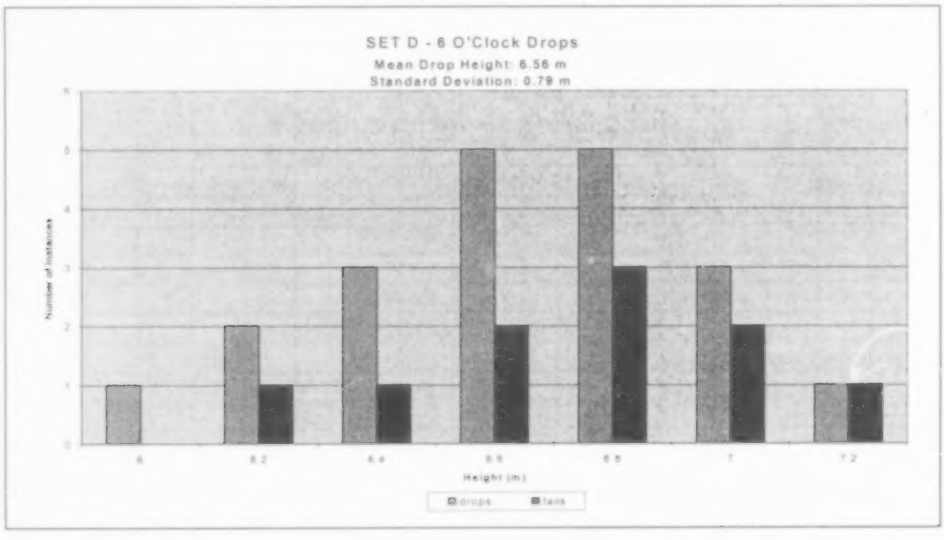
Pressure Test Results, Drum Set D

The mean and standard deviation were calculated to be 6.64 m and 0.66 m, respectively. Even at these extreme heights, there were no catastrophic failures, with most failures consisting of a slight leak at the closure or a small pin-hole at a fold.
